EPSON RC+ 4.1.0 SP2 Release Notes

July 15, 2005

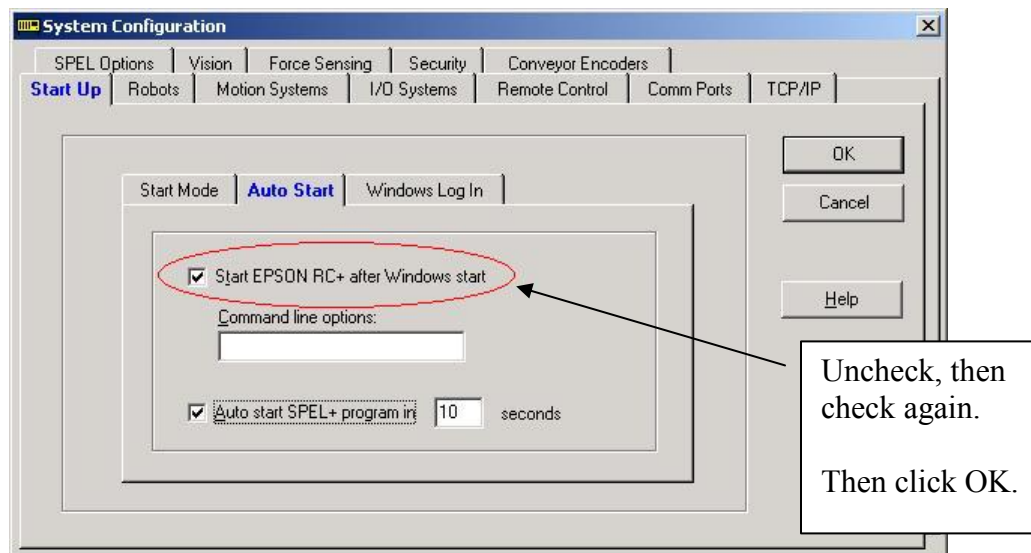
Auto start does not work after upgrading from 3.x versions

If RC+ was configured to auto start after Windows start, it will no longer start up automatically after upgrading to a 4.x version. This is easily fixed.

1. Run EPSON RC+. Click **Change Startup Mode**. Select **Program / Debug**, then click **OK**.
2. Select Setup->System Configuration. On the **Start Up** tab, click the **Auto Start** tab. Uncheck **Start EPSON RC+ after Windows start**. Then check it again. Click **OK**.
